**Zion-Benton Township High School
Main Campus**

DESCRIPTION OF EXISTING CONDITIONS

SITE PLAN
28TH-10 YEAR LIFE SAFETY STUDY - DISTRICT 126
3901 W. 21ST ST. ZION, IL 60099

3901 W. 21ST ST. ZION IL, 60099
ZBTHS 10 YEAR LIFE SAFETY SURVEY - DISTRICT 126
UPPER AND BASEMENT LEVEL FLOOR PLAN

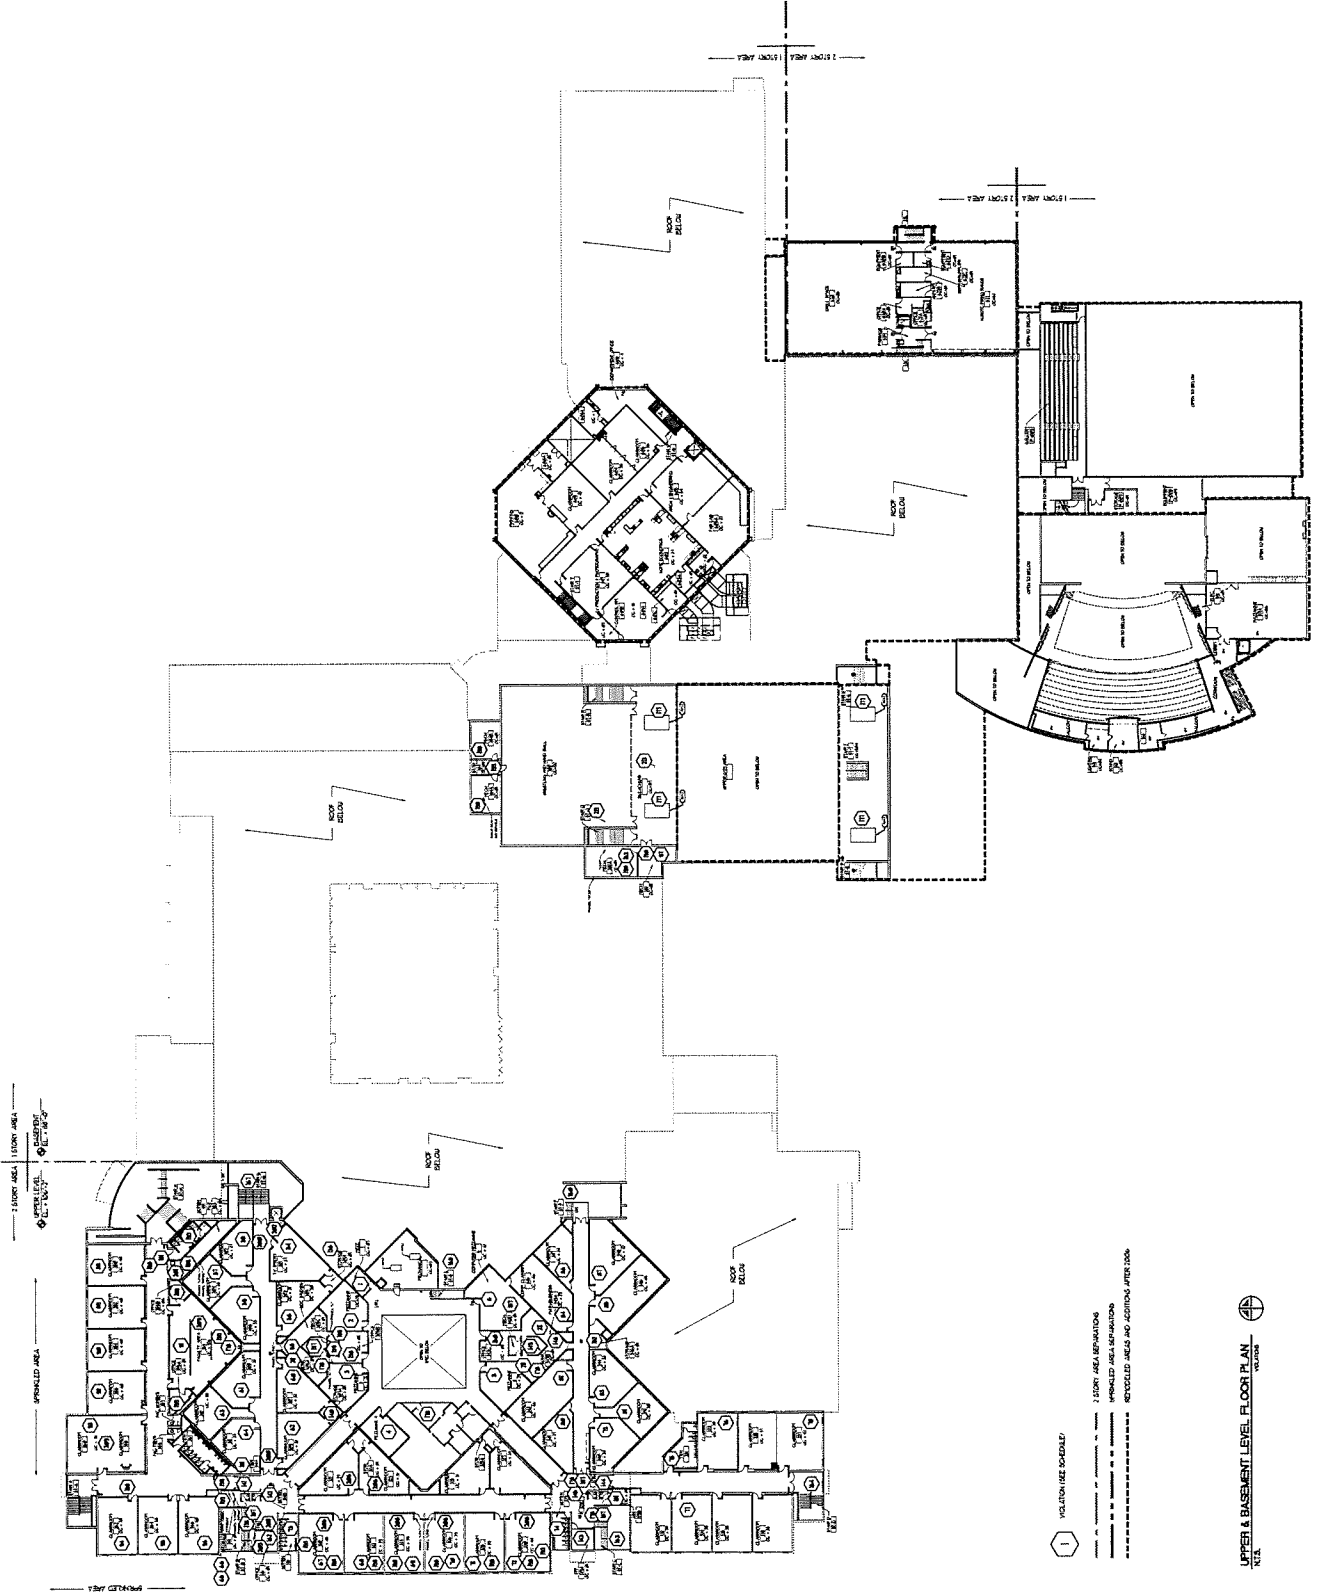
ZBTHS 10 YEAR LIFE SAFETY SURVEY - DISTRICT 126
3901 W. 21ST ST. ZION, IL 60099
UPPER AND BASEMENT LEVEL FLOOR PLANS
